## ICELOCK® RATCHET RECALL– LOCK RELEASE

Reference – FA230301

May 2023

# Inspection for wear - Icelock® Ratchet series

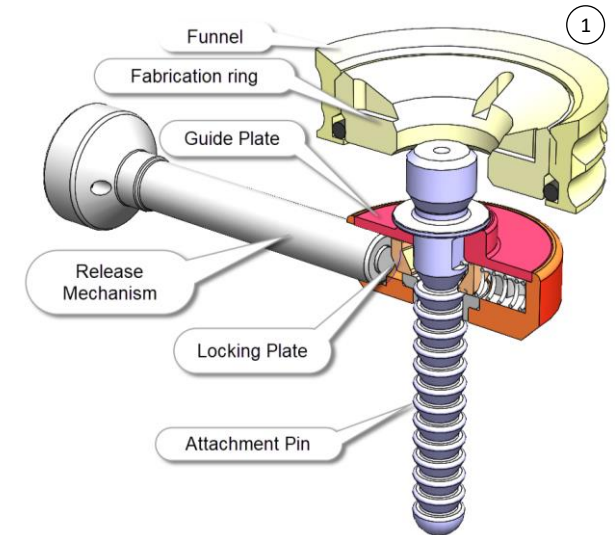
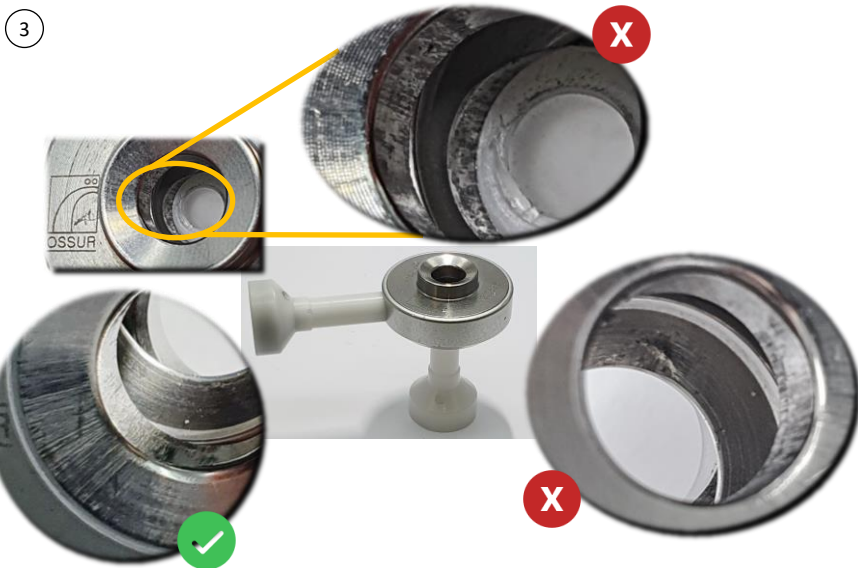
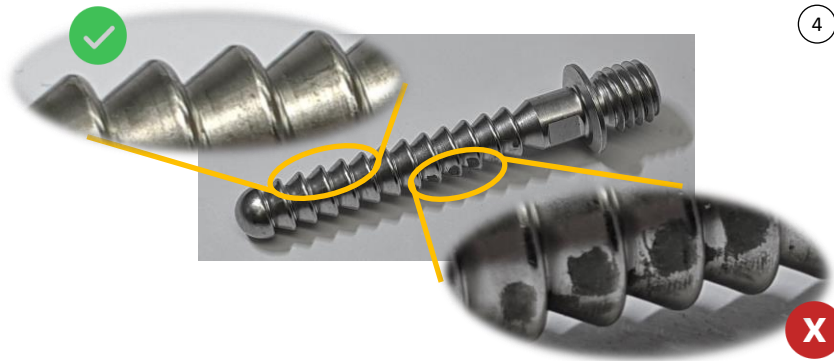
## Acceptable wear:

Small indents and shiny surface on material (not roughened)

## Unacceptable wear

- Material removed in area of contact with the pin
- Large indents, scratches or gouges
- Roughened surfaces

Wear on **Guide Plate** is usually concentrated but can be oriented differently from the guide plate. Wear would be identified as material removal with deep scratches visible (see red area on image 2).

Wear on **Locking Plate** is mostly concentrated in one location and wear can be seen by material being removed and scratches are visible (see red area on image 2).

Shiny surface, being different from other similar surfaces is usually acceptable as this is normal to see with steel parts rubbing against each other. Indents, scratches and gouges of darker color may be sign of early wear through steel outer protective layer which can escalate into higher degree of wear.

Irrespective of one part showing wear, Lock and Attachment pin must be replaced.

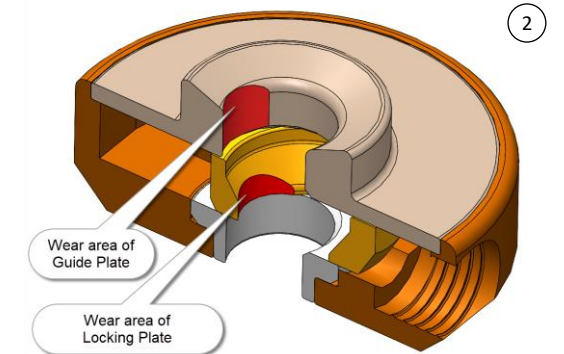
## Assistive tools:

- Directional light or other good lighting
- Compressed Air for cleaning
- Magnifying glass for inspection or mobile phone with camera to zoom in on areas
